TECHNICAL INSPECTION REPORT

6 OPERATION CROSSROADS.
U.S.S. CRITTENDEN (APA 77)

TEST ABLE.

VOLUME 2 [U].

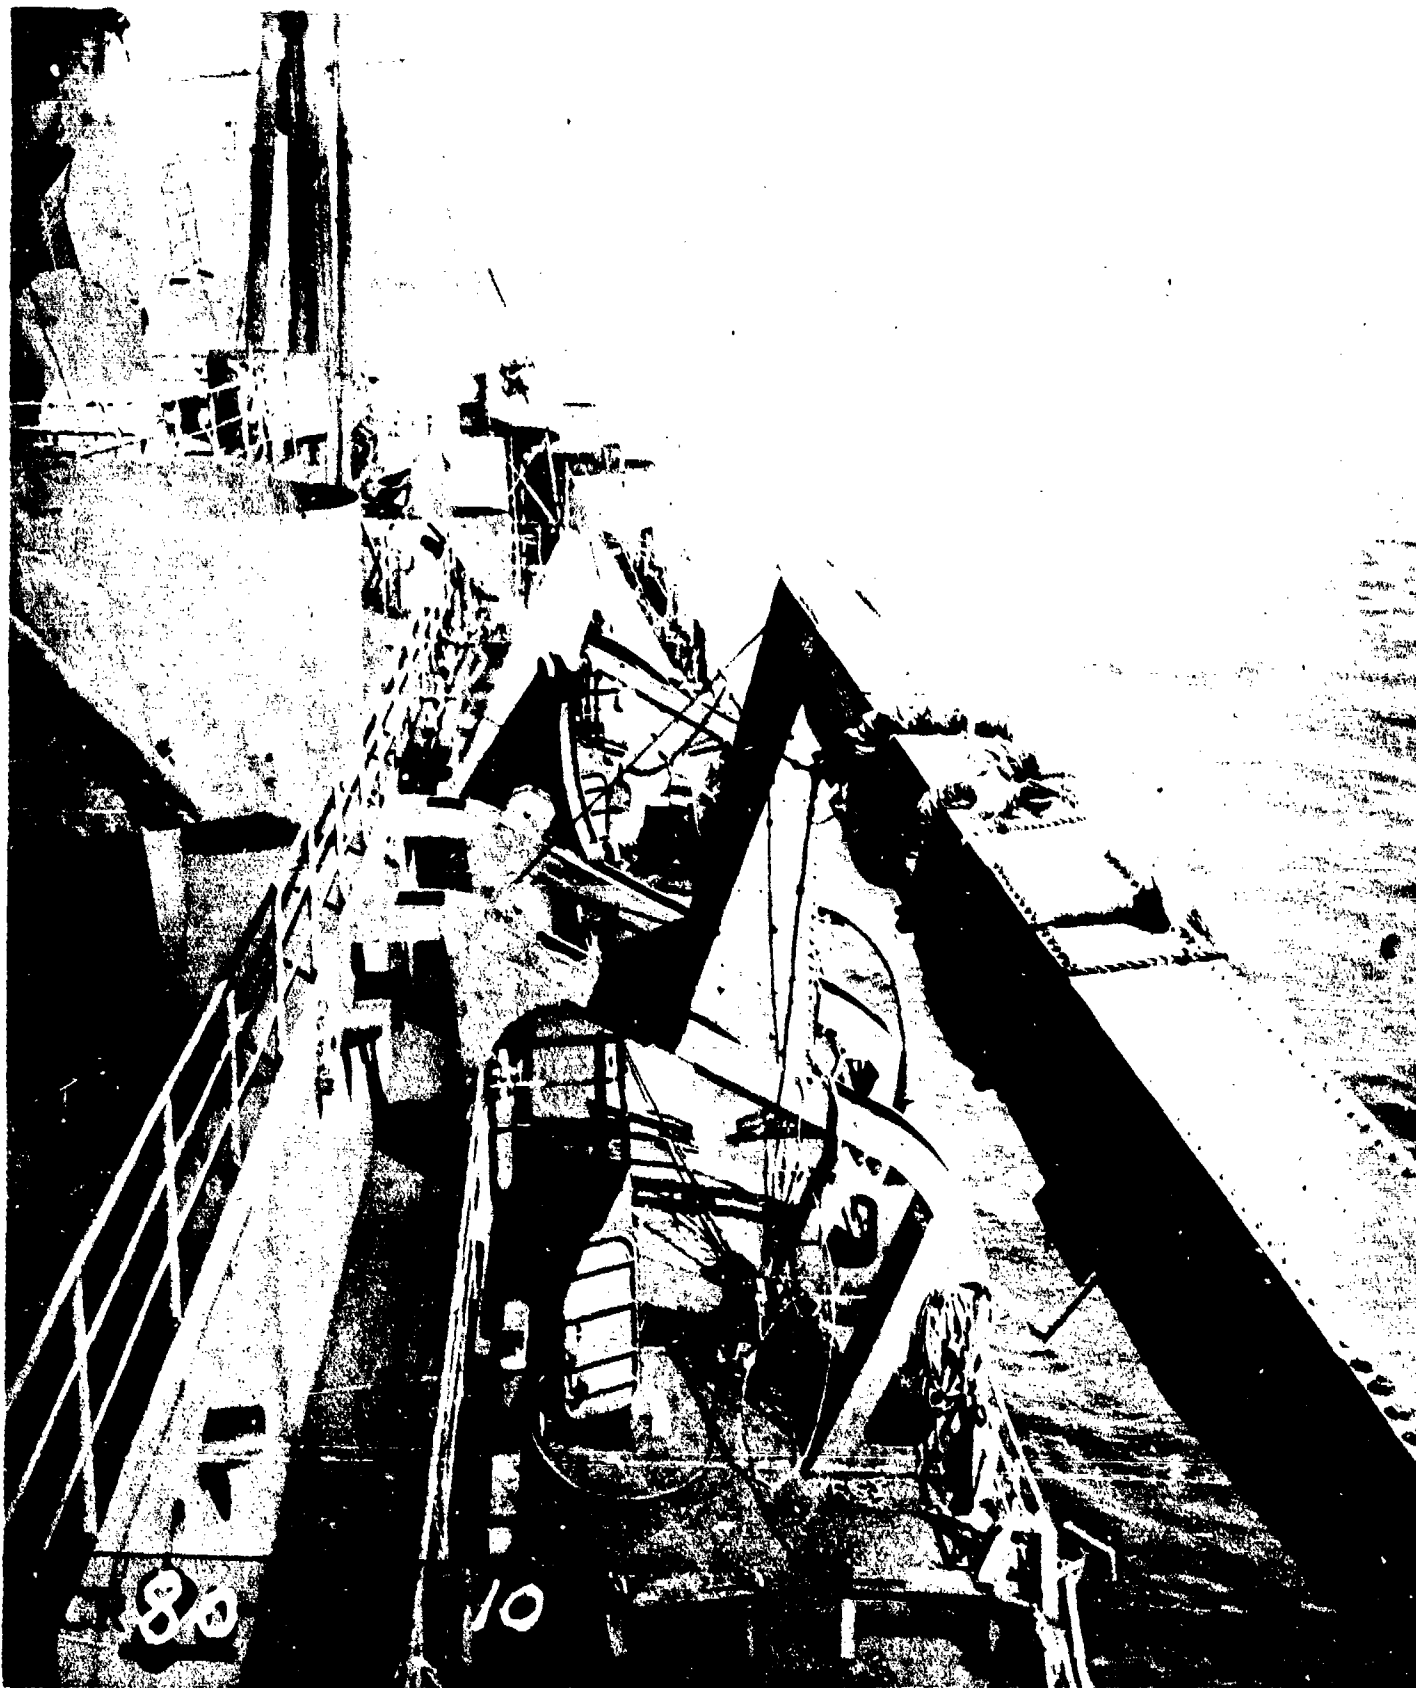
AA-CR-80-1904-10. Looking aft along port side of deck house showing damage to port davits.

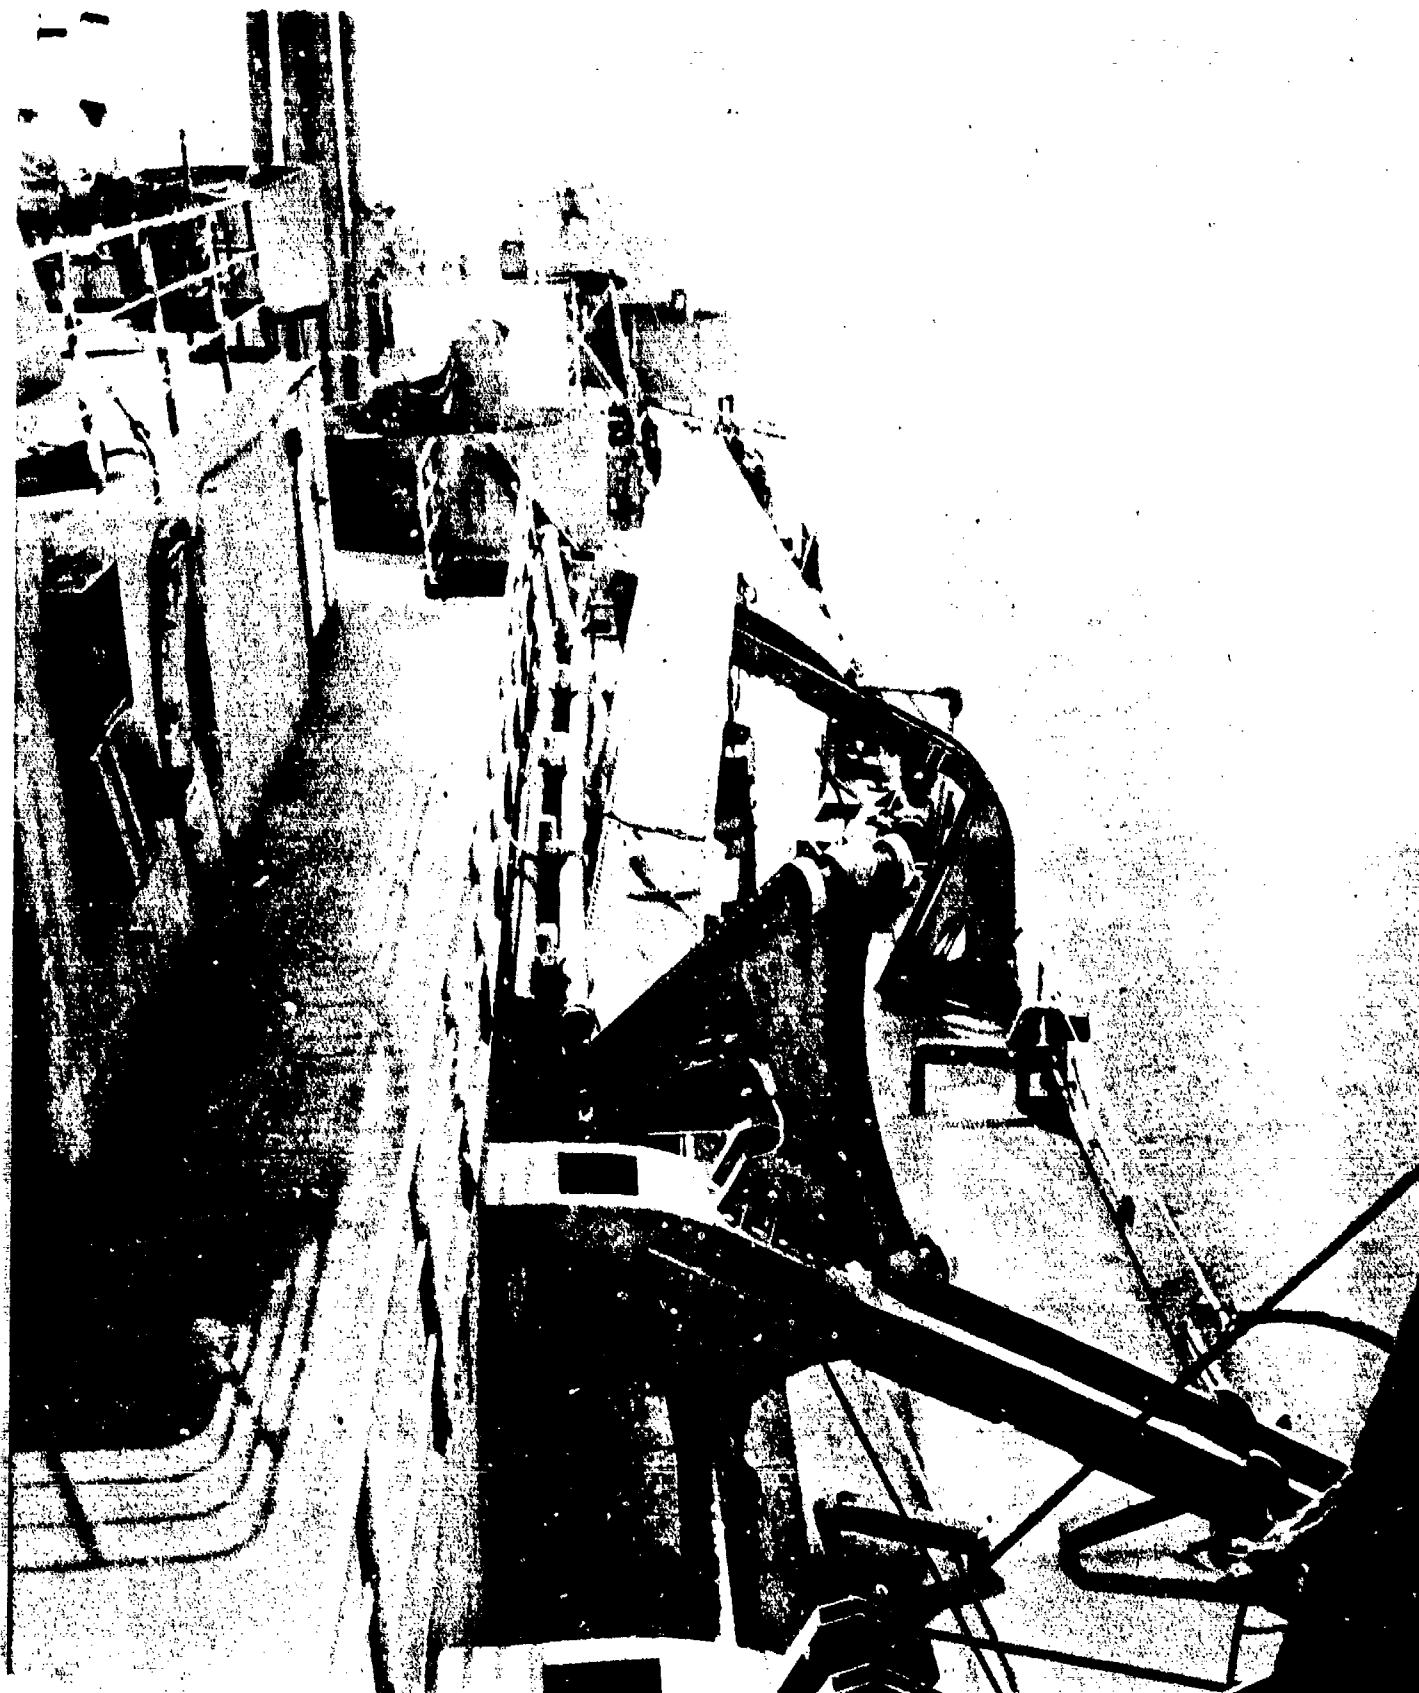
AA-CR-82-1922-3. Looking aft along port side of deck house showing damage to davit at frame 89 and sky lookout tub at frame 100.

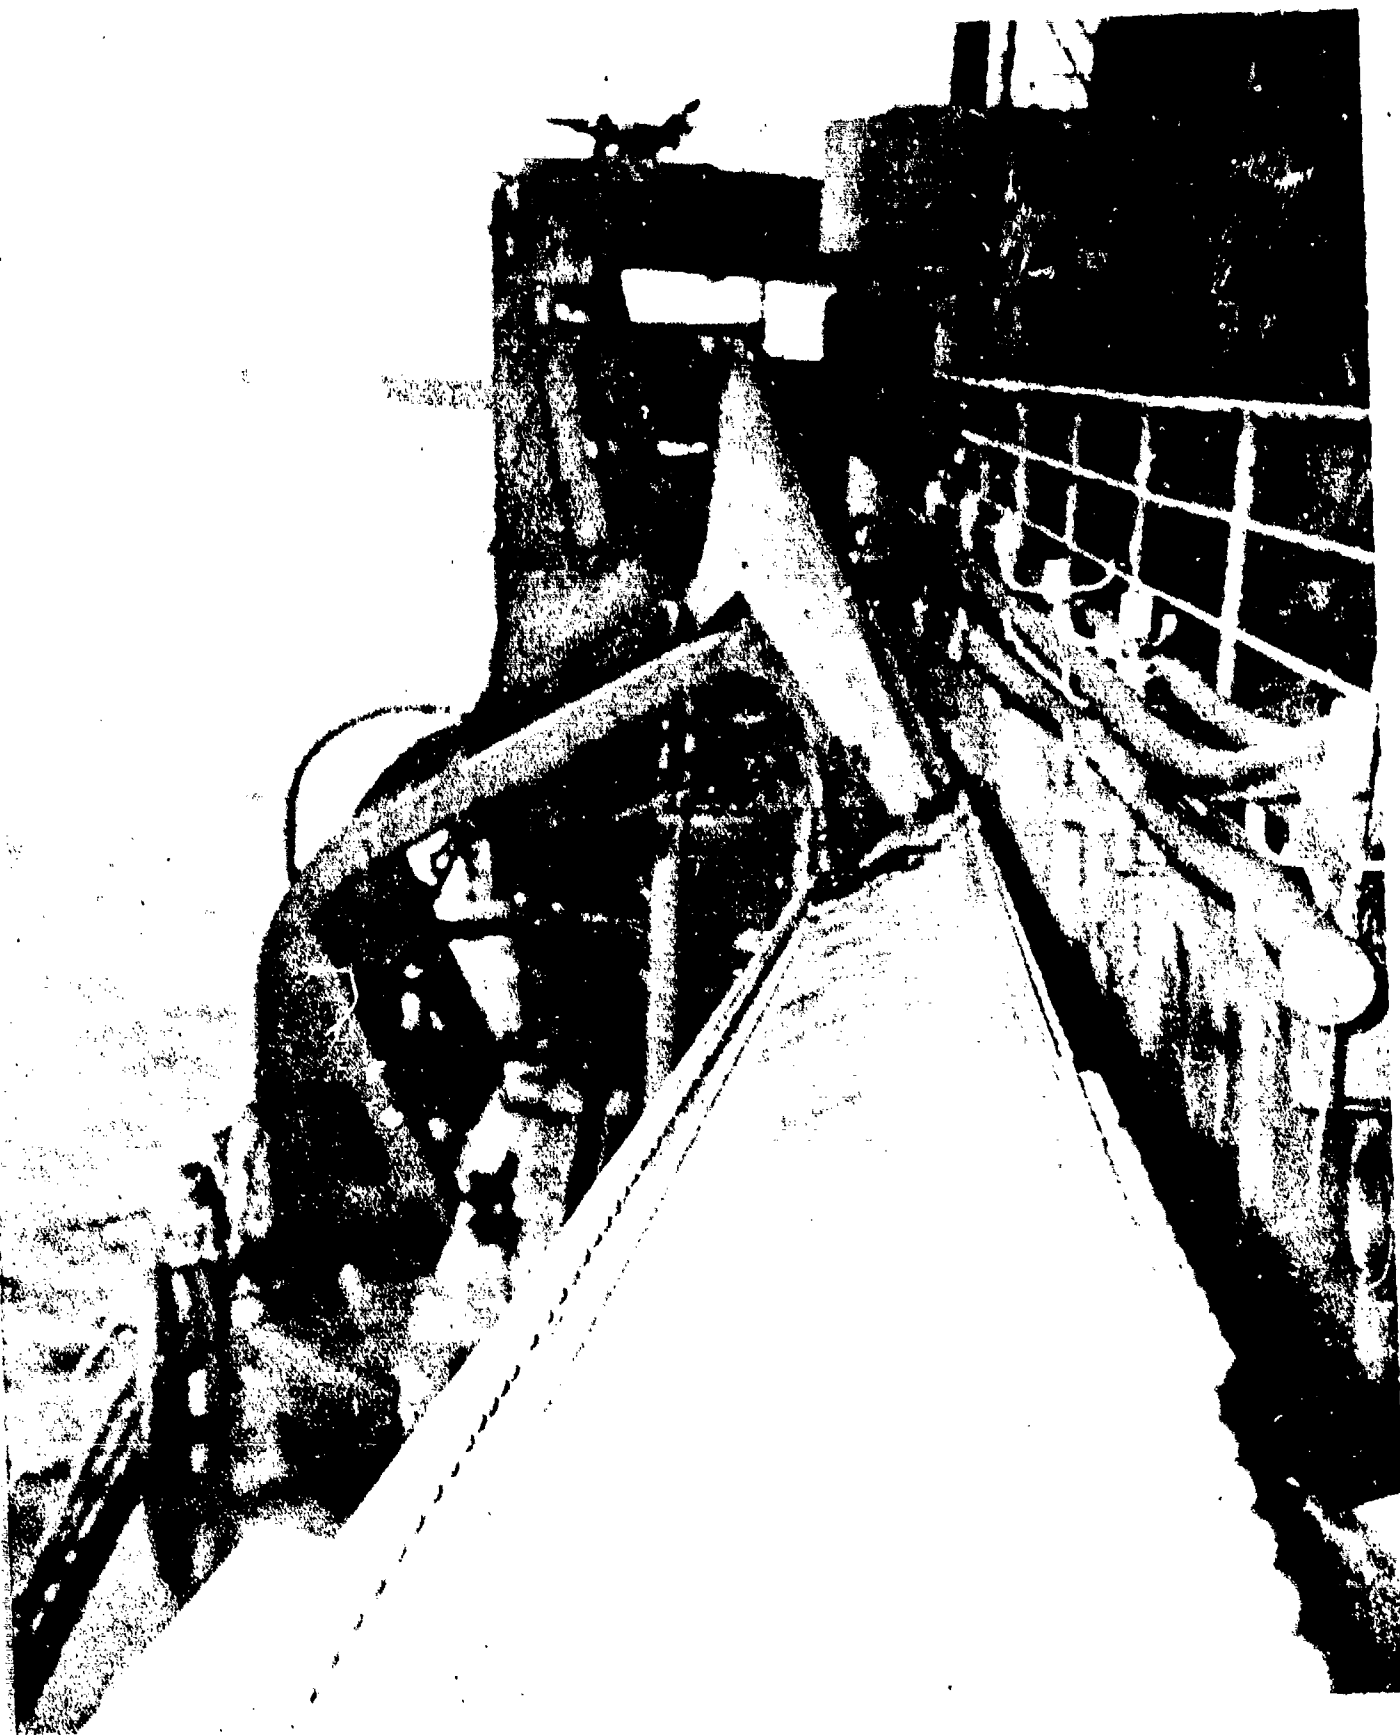
AA-CR-62-1882-6. Looking forward along port side of deck house showing damage to number 4 davit.

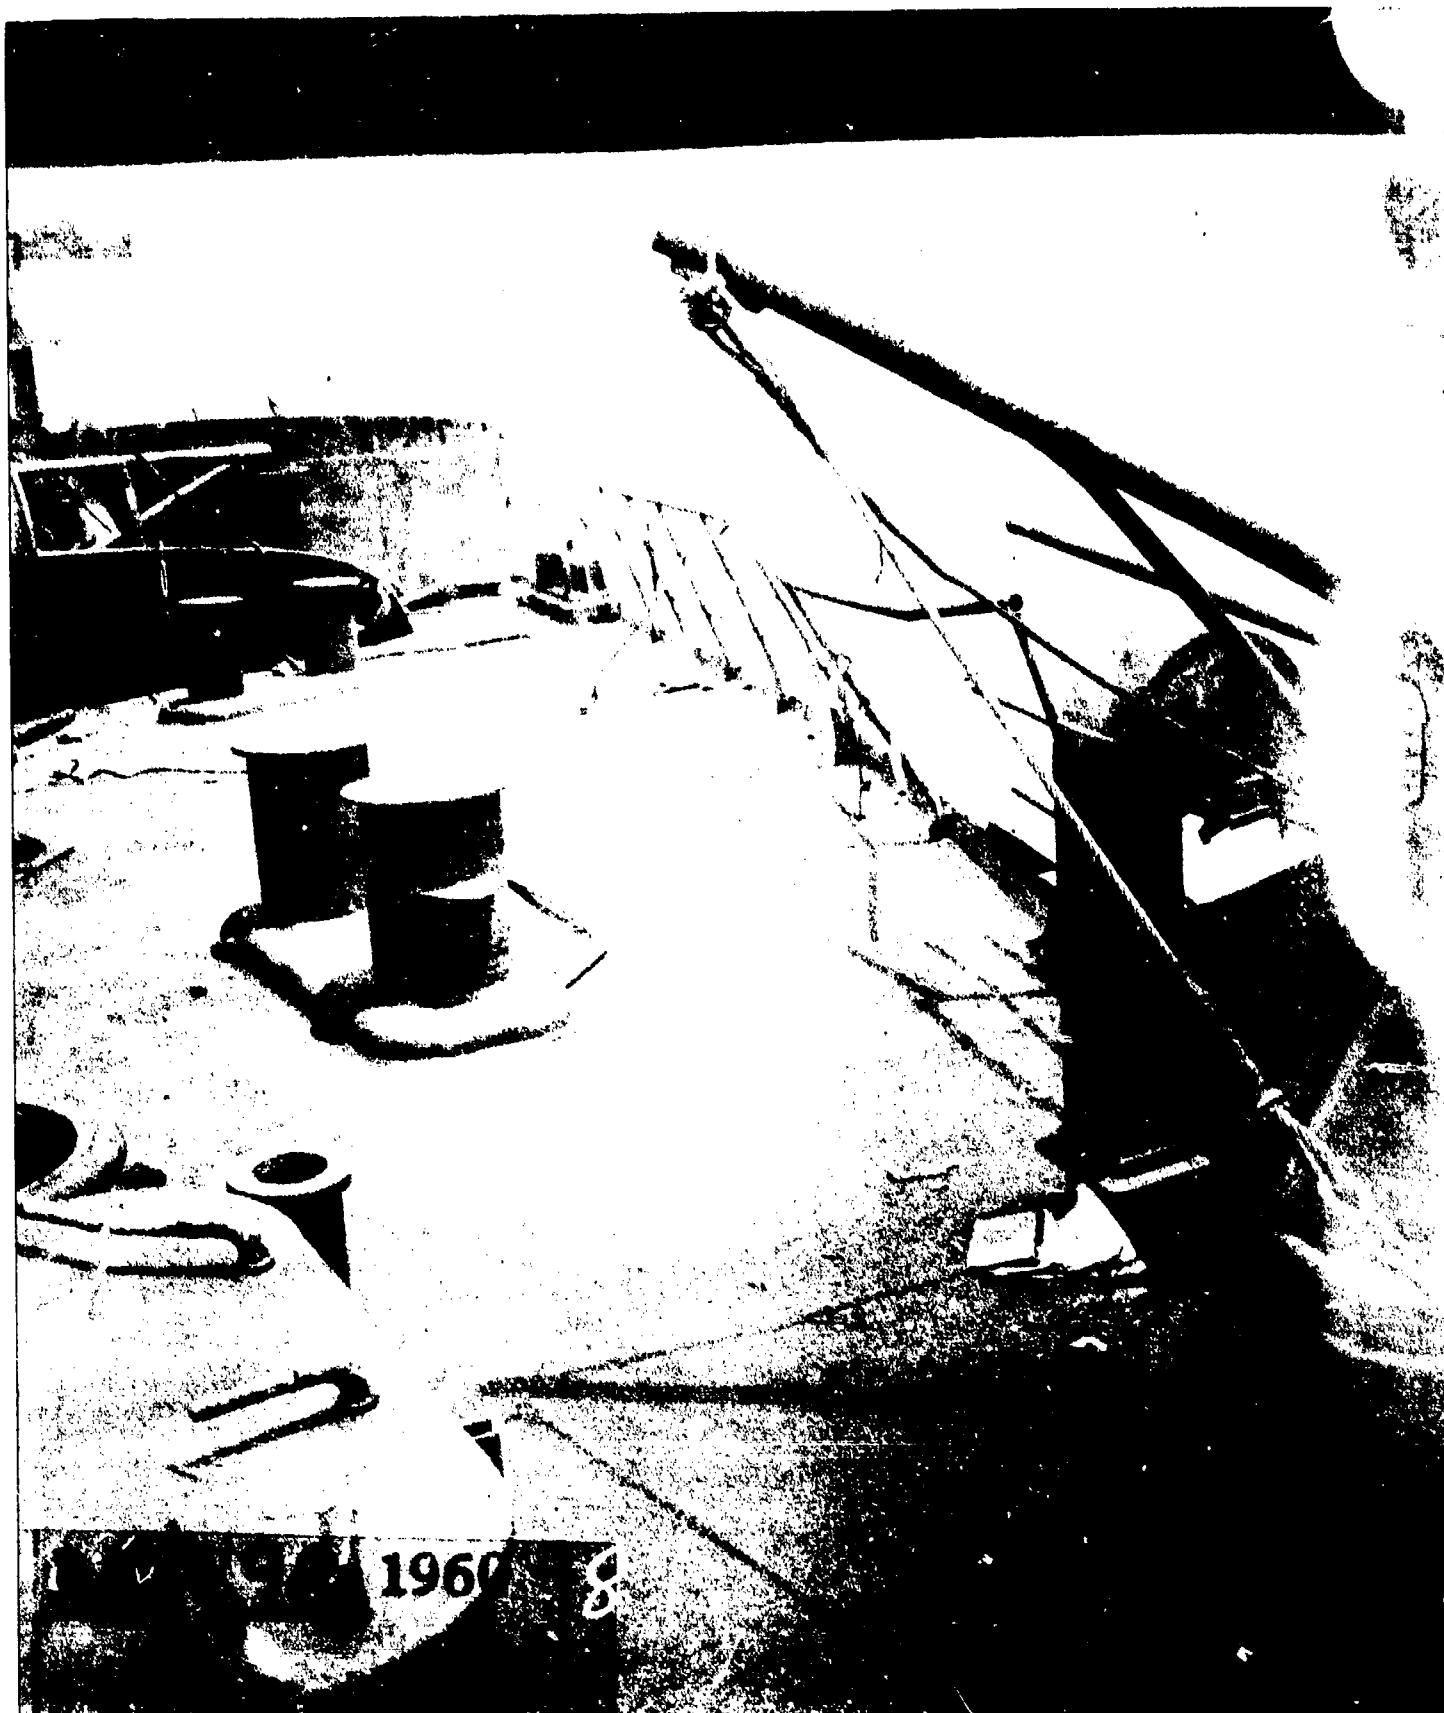
AA-CR-98-1960-8. Looking aft on upper deck, port, from bow, showing damaged railing.

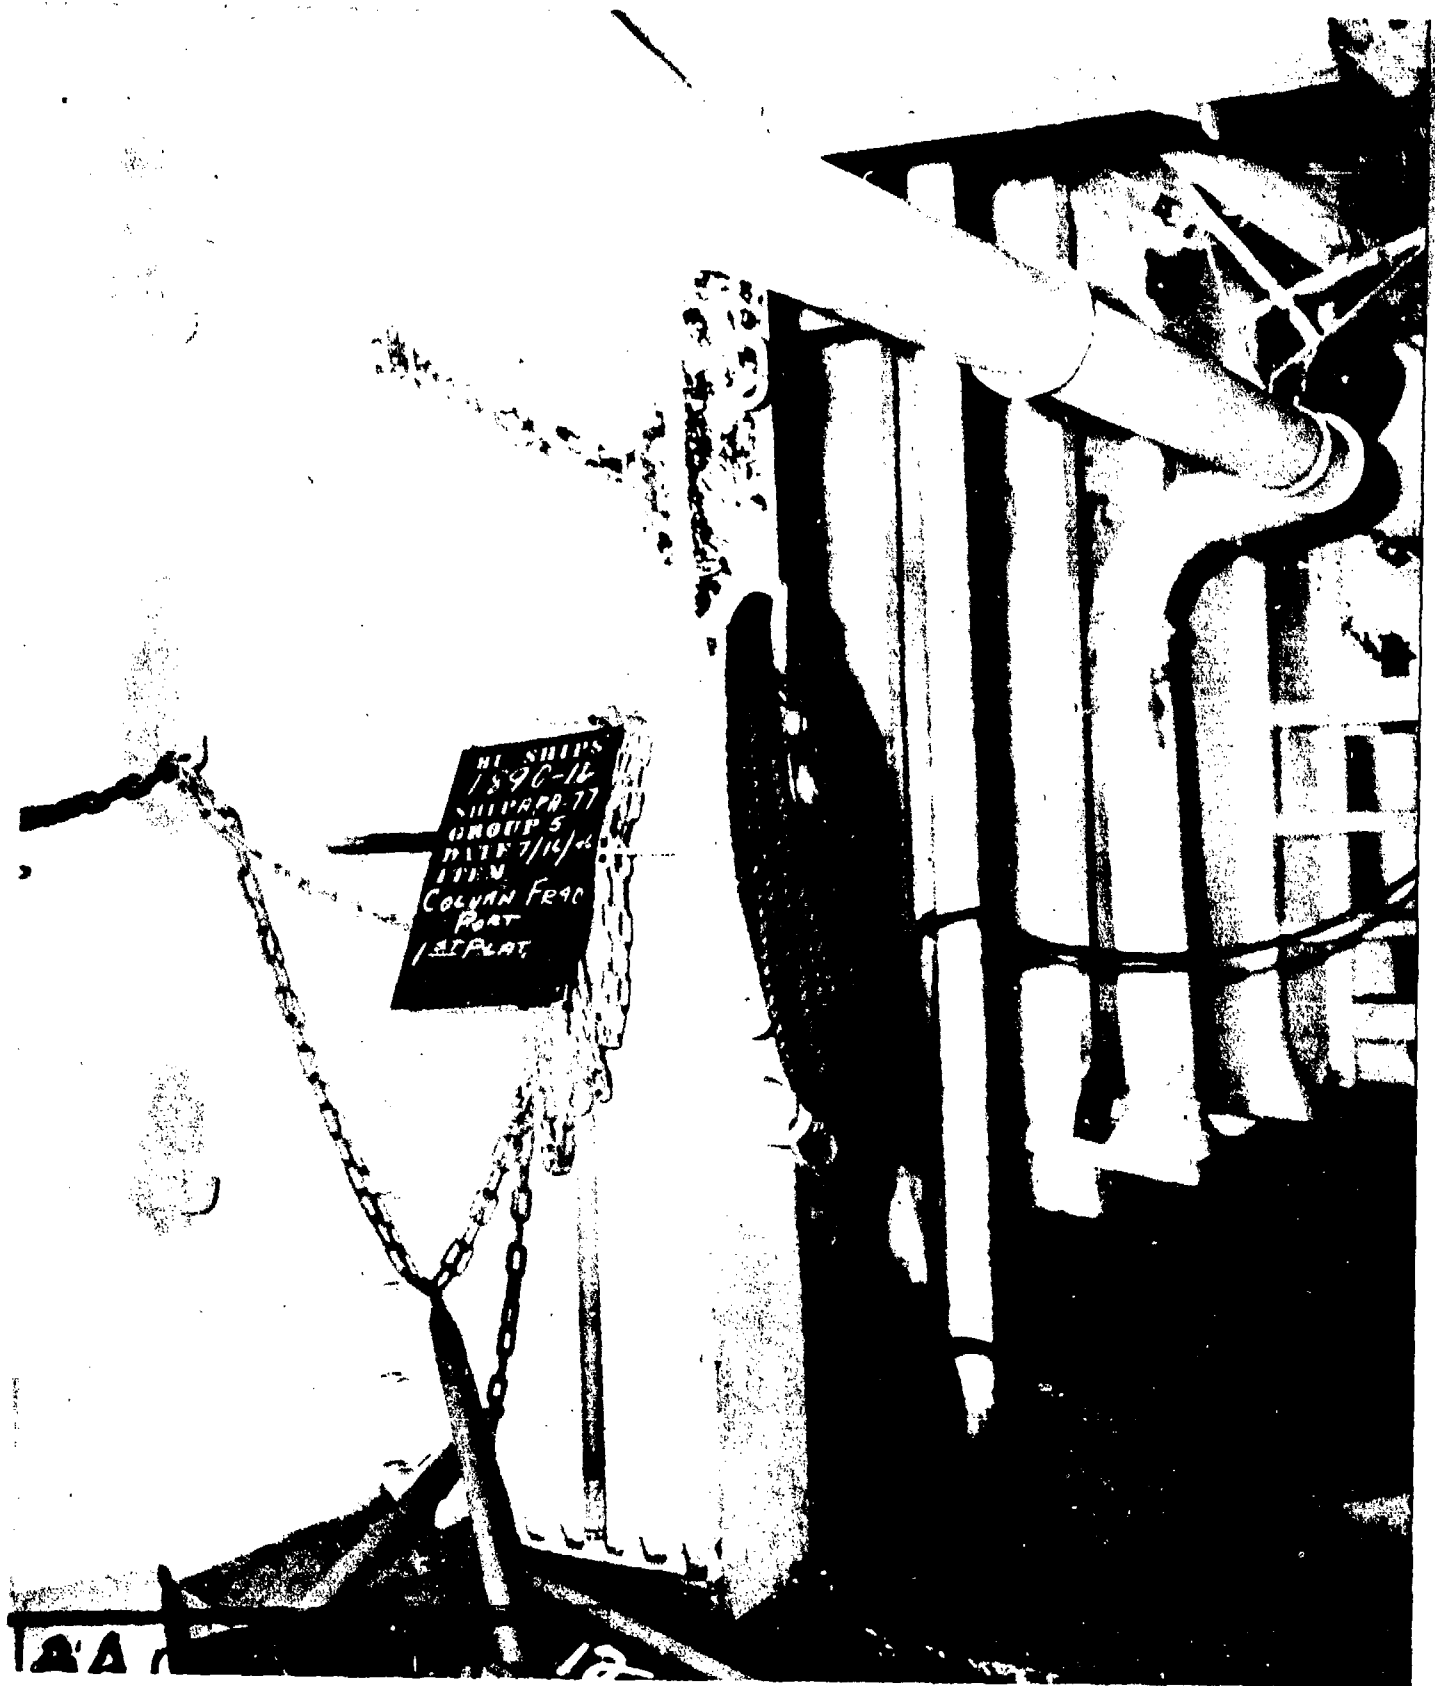
AA-CR-100-1890-12. Looking forward and to starboard along bulkhead 40 on first platform in forward cargo hatch area showing damage to column in way of port edge of hatch.

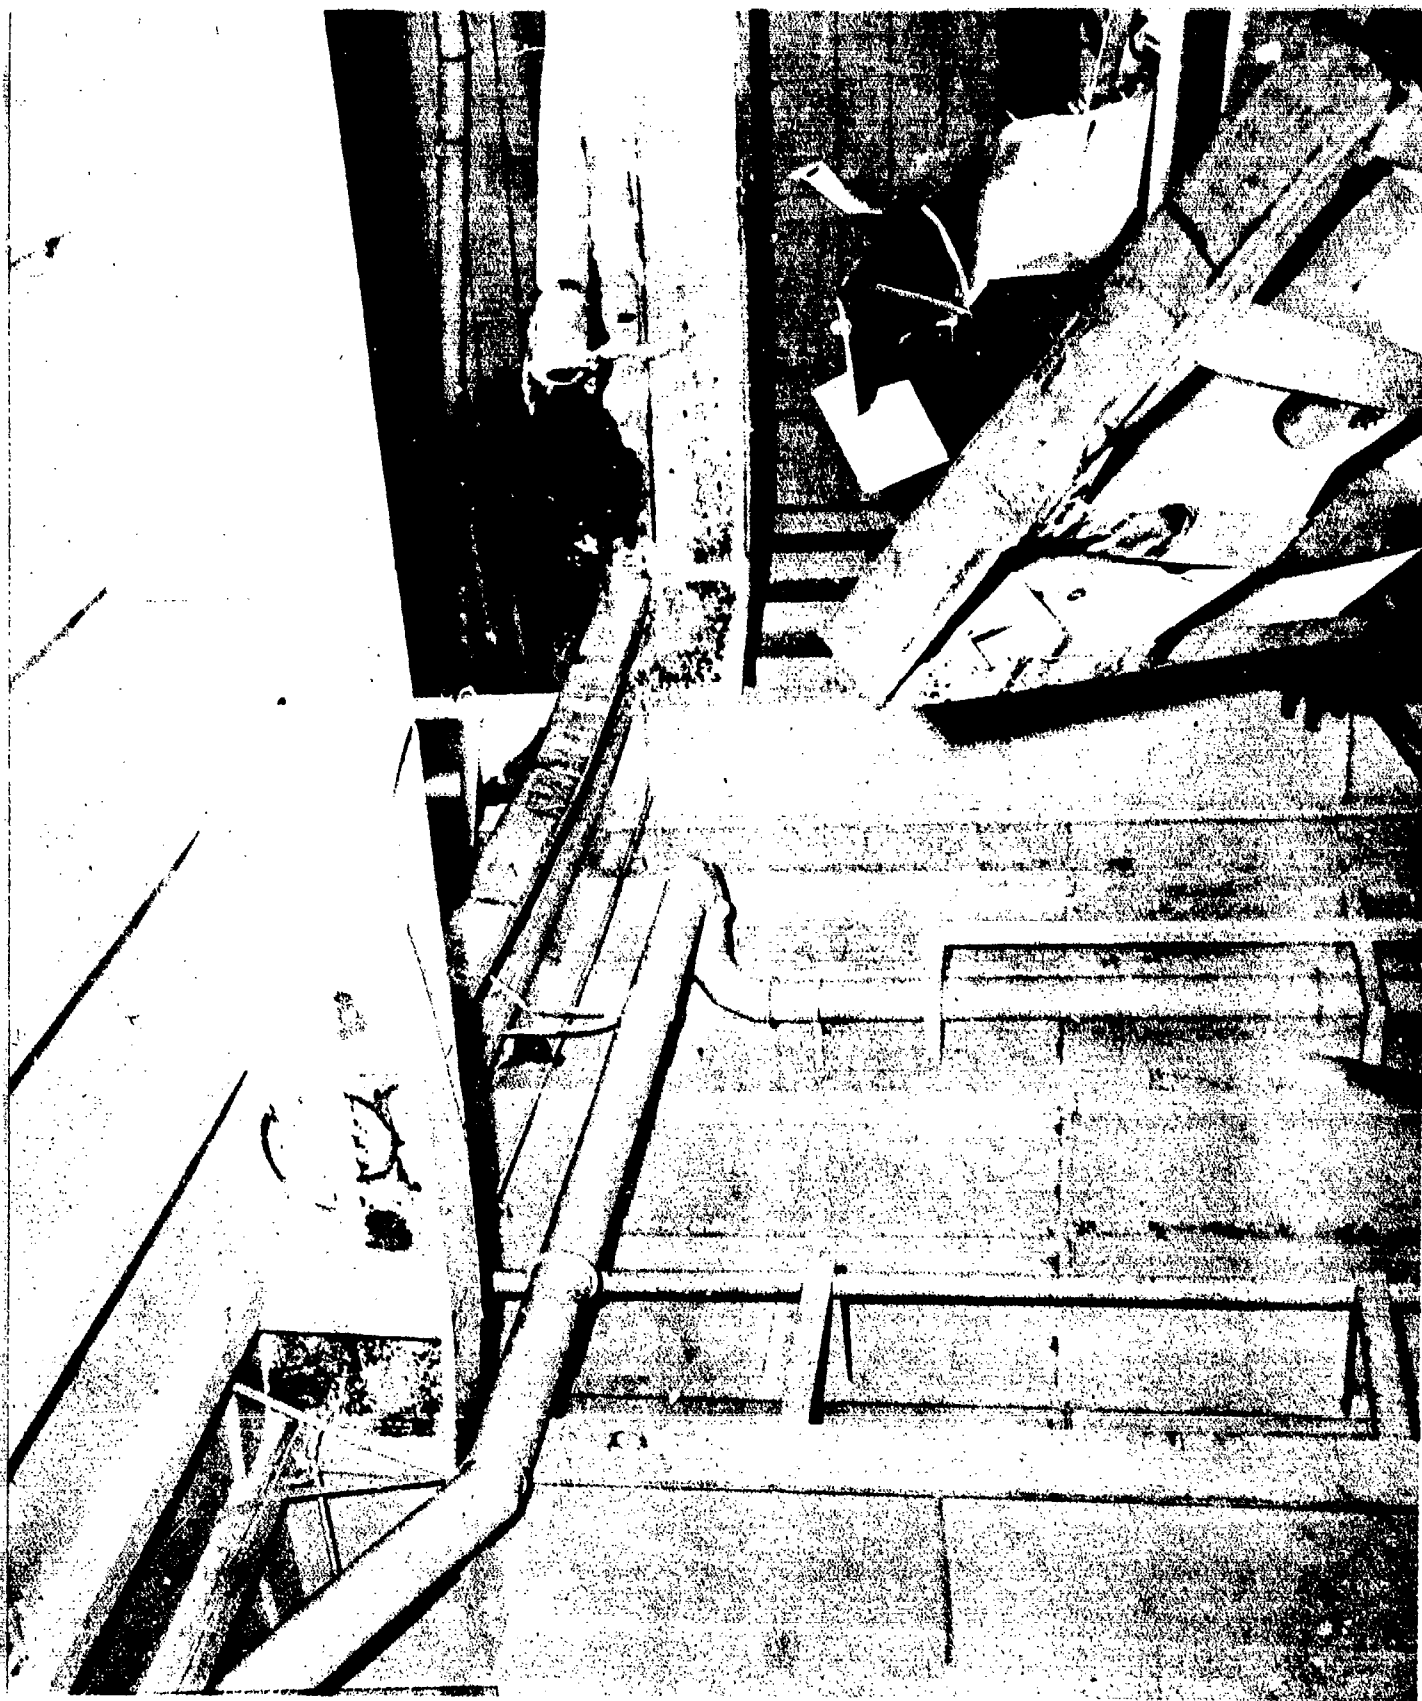
AA-CR-80-1907-10. Looking forward and to starboard in forward cargo hold showing damage to hatch girders near bulkhead 40.

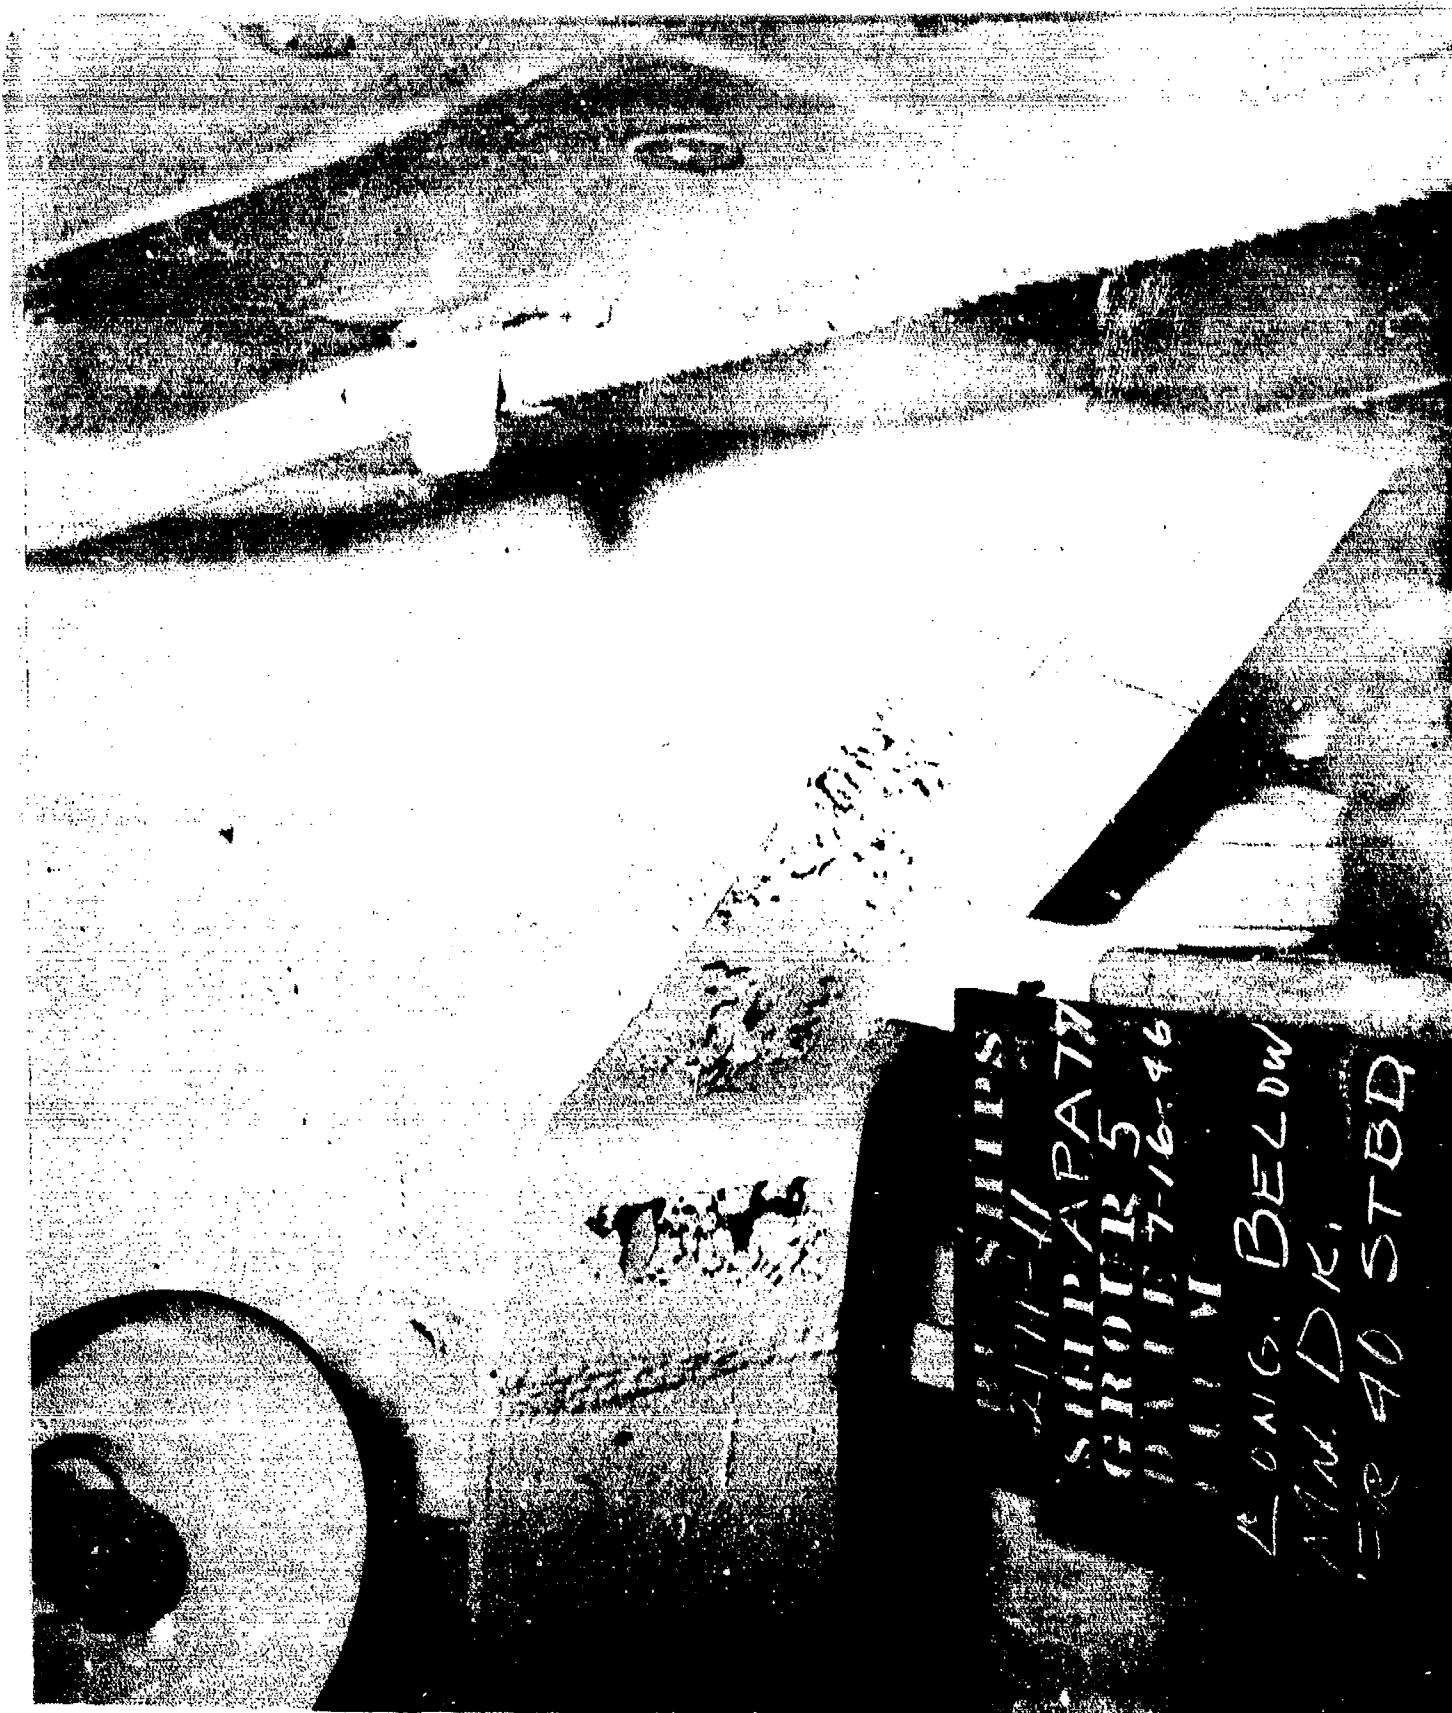
AA-CR-62-2171-11. Looking to starboard on first platform showing damage to longitudinal under main deck adjacent to forward side of bulkhead 40.

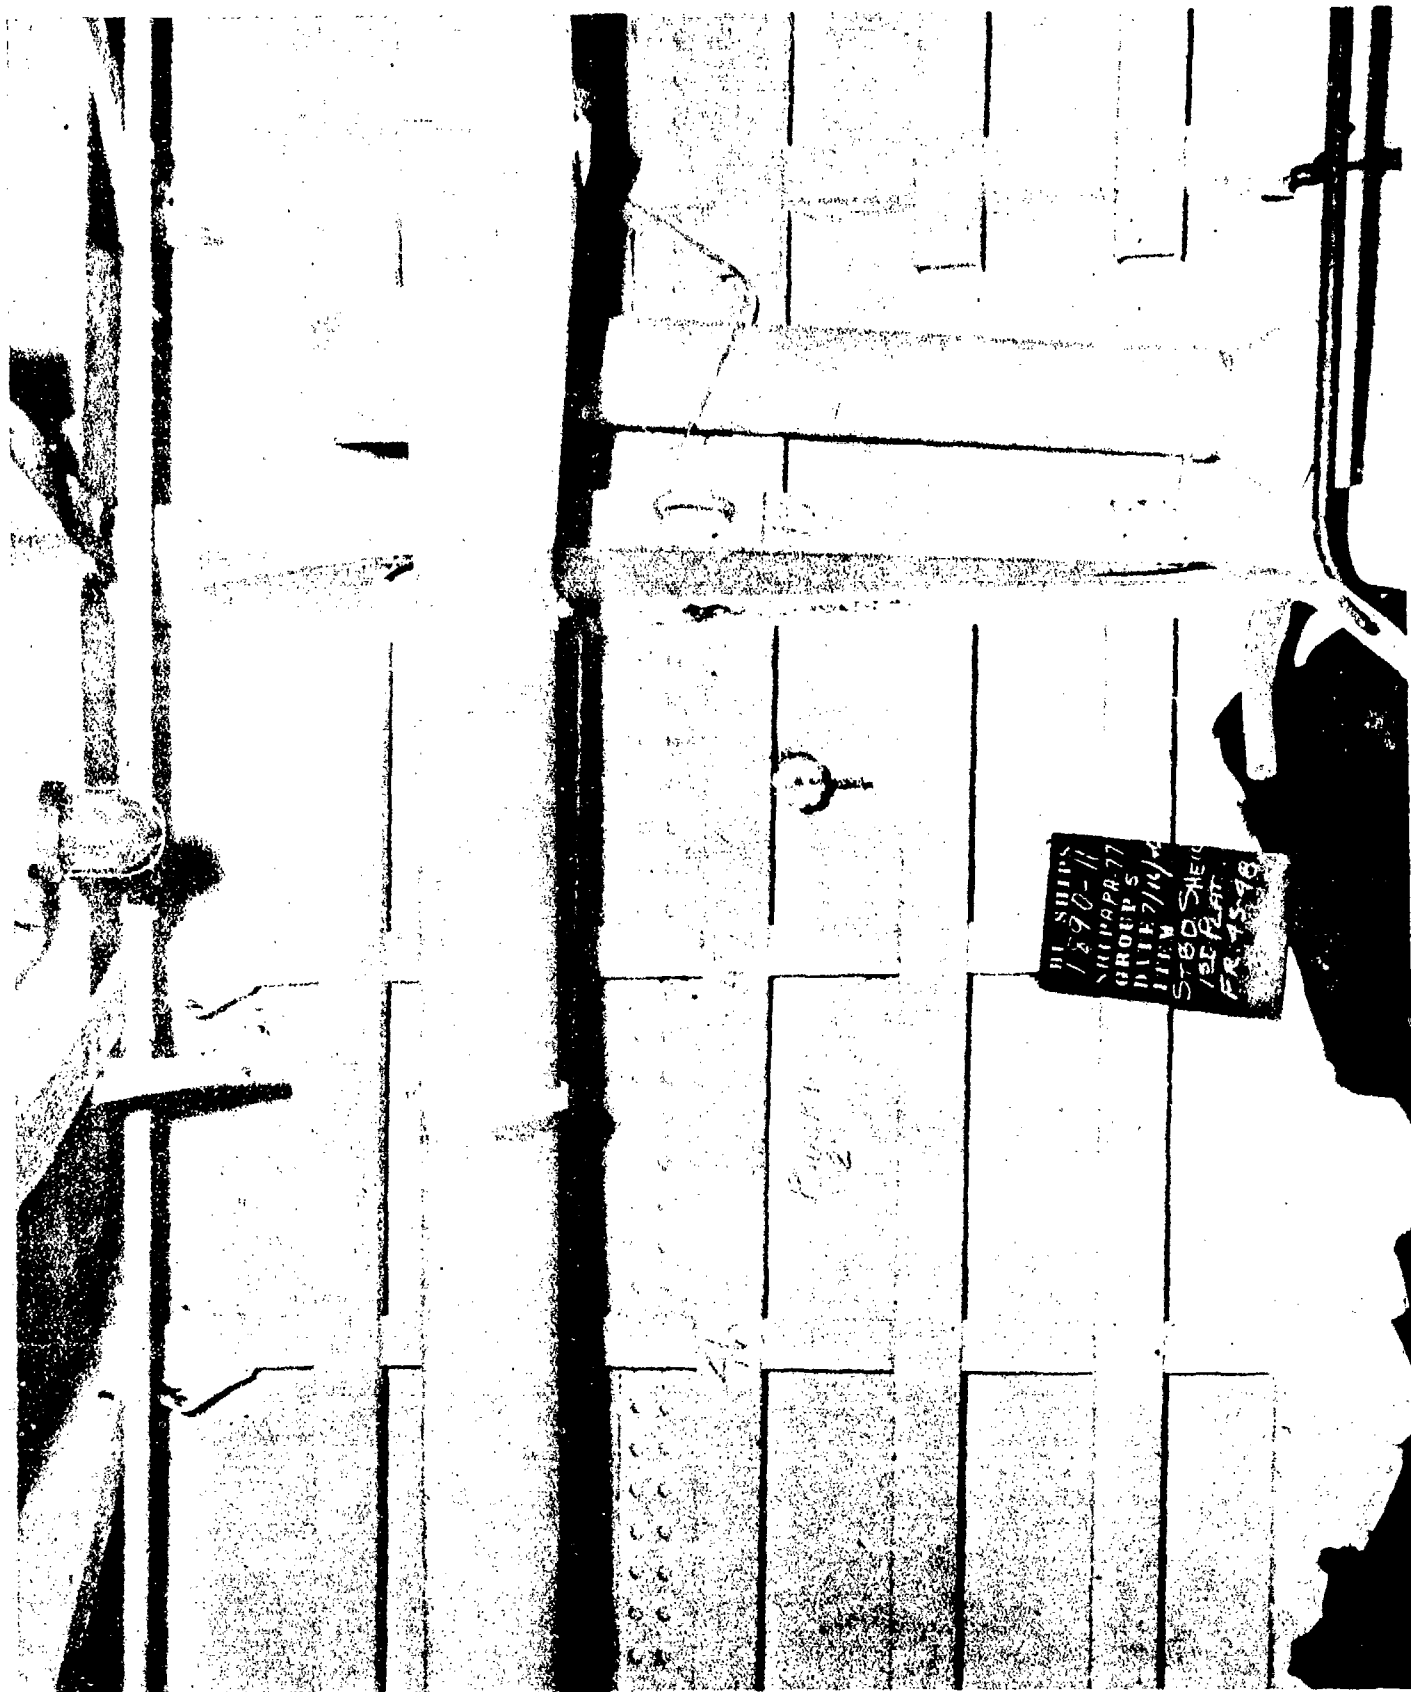
AA-CR-100-1890-11. Looking to starboard on first platform in forward cargo hatch area showing damage to web frame 48 and to brackets under main deck at starboard shell. Refer to 2086-7.

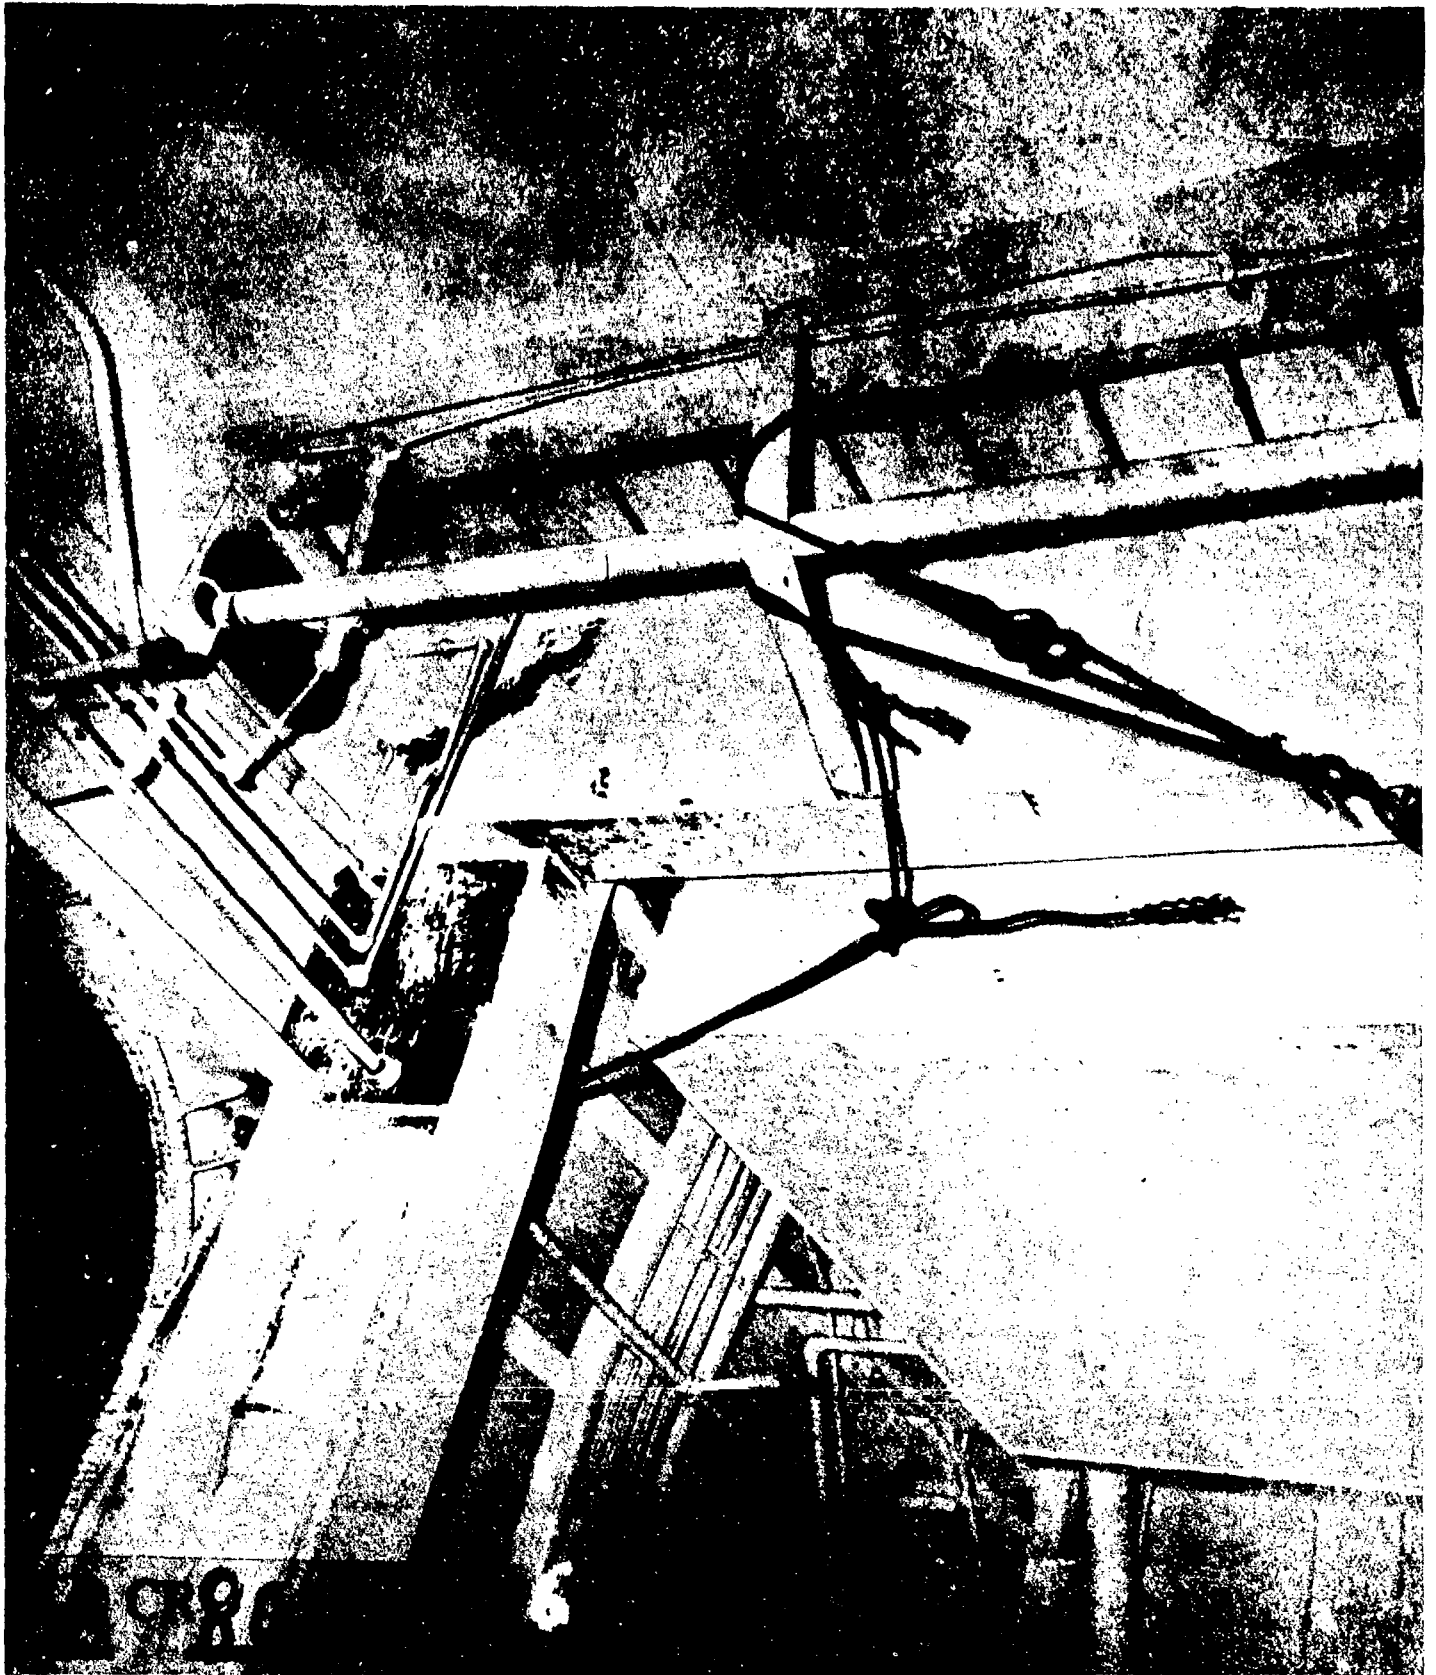
AA-CR-80-1908-6. Looking up, aft, and to starboard in after cargo hold showing damage to web column and main deck girder at starboard edge of hatch.
